### **U.S. Model 1897 Combination Tool ("Screwdriver") For Krag Jorgensen Carbine and Rifle**

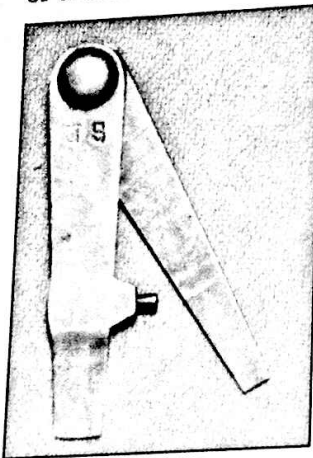
PHOTO 1

Photo 1 shows the tool as it is most often seen. Photo 2 shows the standard tool (top) compared with an armory-misassembled tool, where the larger arm was reversed for stamping and assembly. The tool at the top is the type shown in the 1898 Krag manual.

The Krag combination tool was called a "screwdriver" in the 1898 Manual and was not designated with a model number. However, an original Springfield Armory drawing calls it a "M1894"—a term never reaching the field or the manuals (19). Later Springfield Armory production records call it a "Model 1897."

Packed four for every 20 carbines or rifles shipped, it is not certain this tool was intended to be issued with each weapon. Though both the carbine and rifle have butt traps, neither were designed to accommodate the tool. The tools are coarsely polished and blued as well as marked "U.S." on the pin leg.

OAL 2 1/2"

OAW At Pin 11/16"
